VERMONT DIVISION FOR HISTORIC PRESERVATION
HISTORIC SITES & STRUCTURES SURVEY

RUTLAND COUNTY

RUTLAND TOWN

HISTORIC SITES & STRUCTURES SURVEY
Individual Structure Survey Form

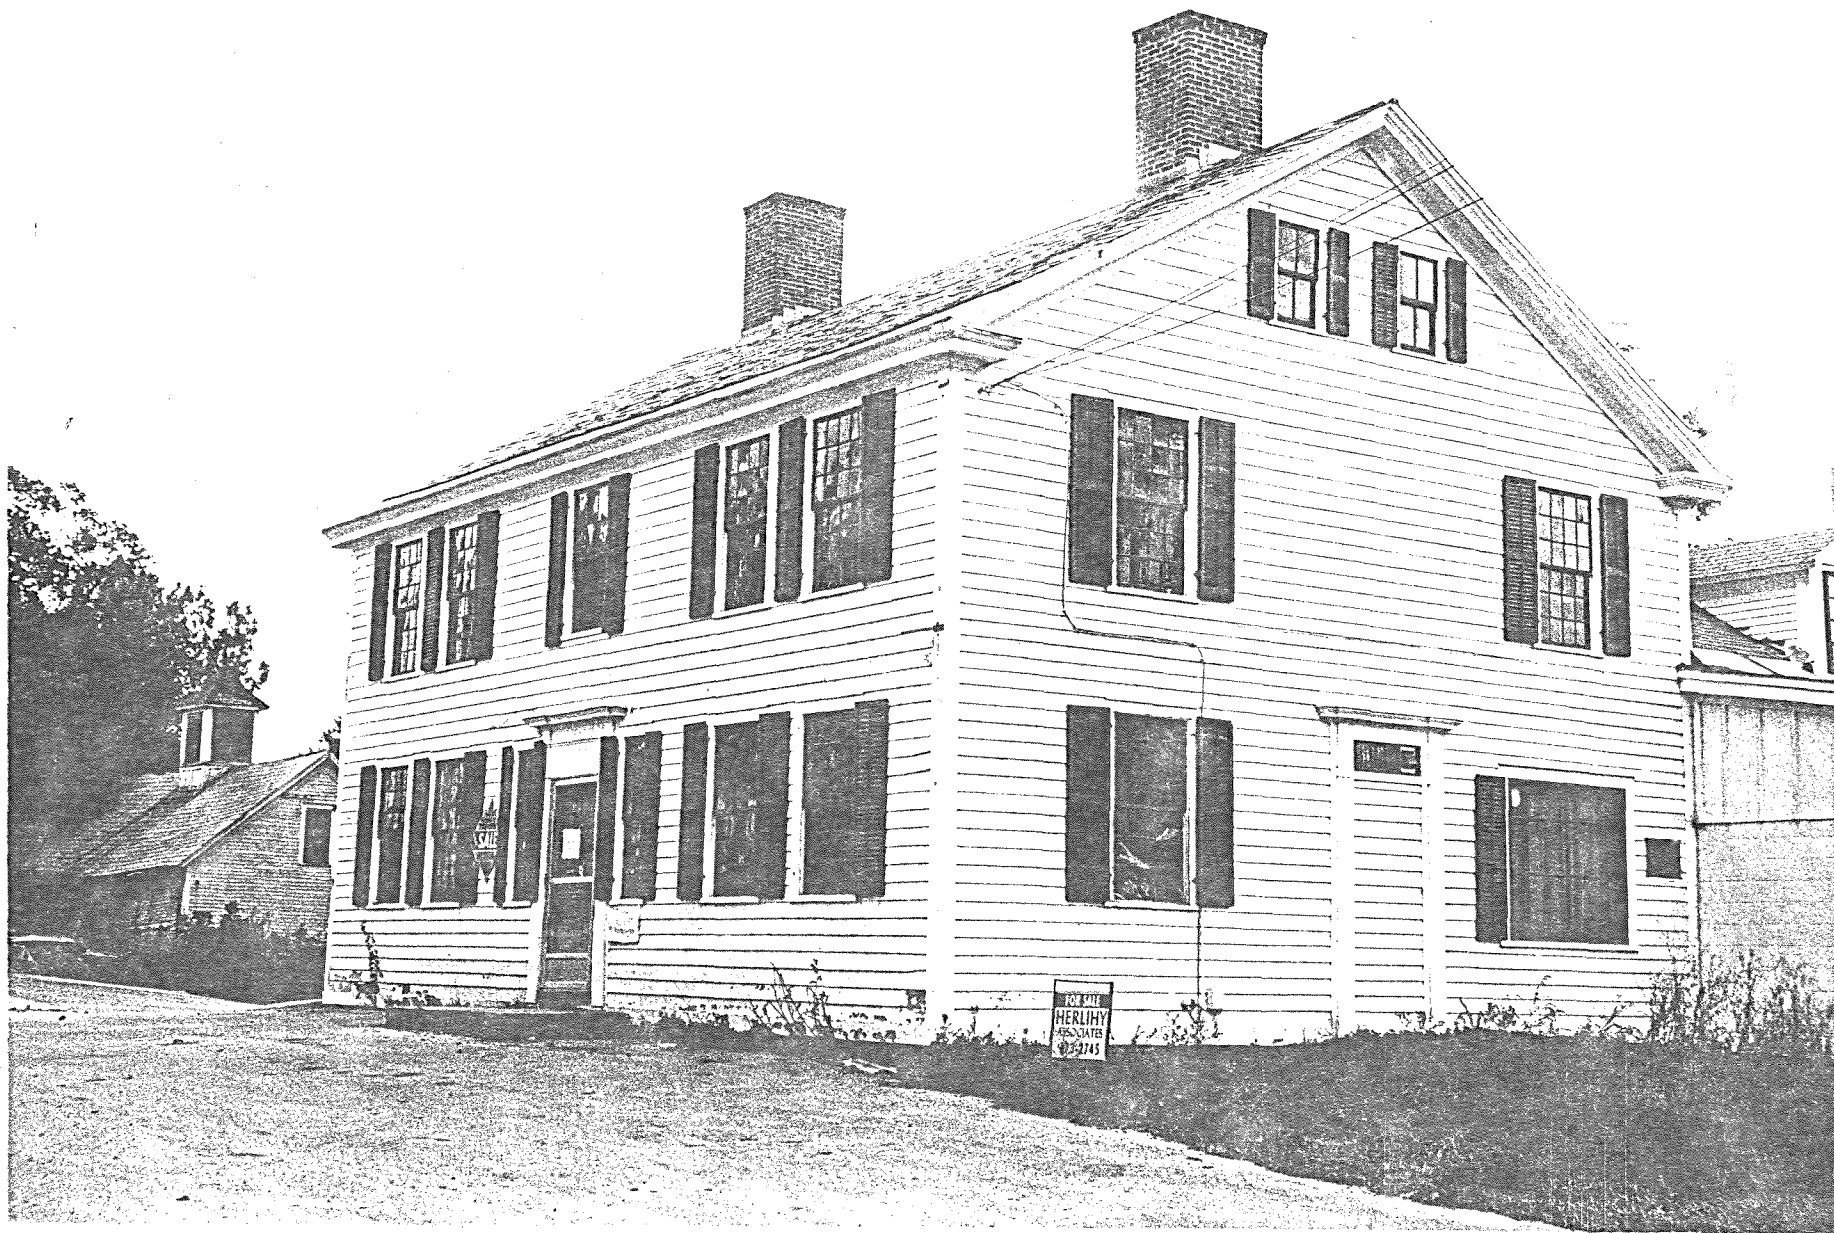
1120-1

The facade of this Federal-period house is five bays wide and has a center entrance flanked by double-hung sidelights. The doorway is framed by slender pilasters and a simple entablature. The transom has been removed but the wide original door is intact. All windows have early 12/12 glazing.

On both elevations are narrow, centered entrances with pilasters, entablature, and a four-light transom. A garage door was cut into the south side of the house when the building served as a car dealership. There are several, later extensions at the rear.

Despite several recent alterations, the original form and detailing of this handsomely proportioned Federal-style house are intact. The building is located at a bend in Route 7 and serves as a landmark at the northern entrance to Rutland City. Currently surrounded by a parking lot and zoned for commercial development, it is threatened by demolition or an incompatible reuse.

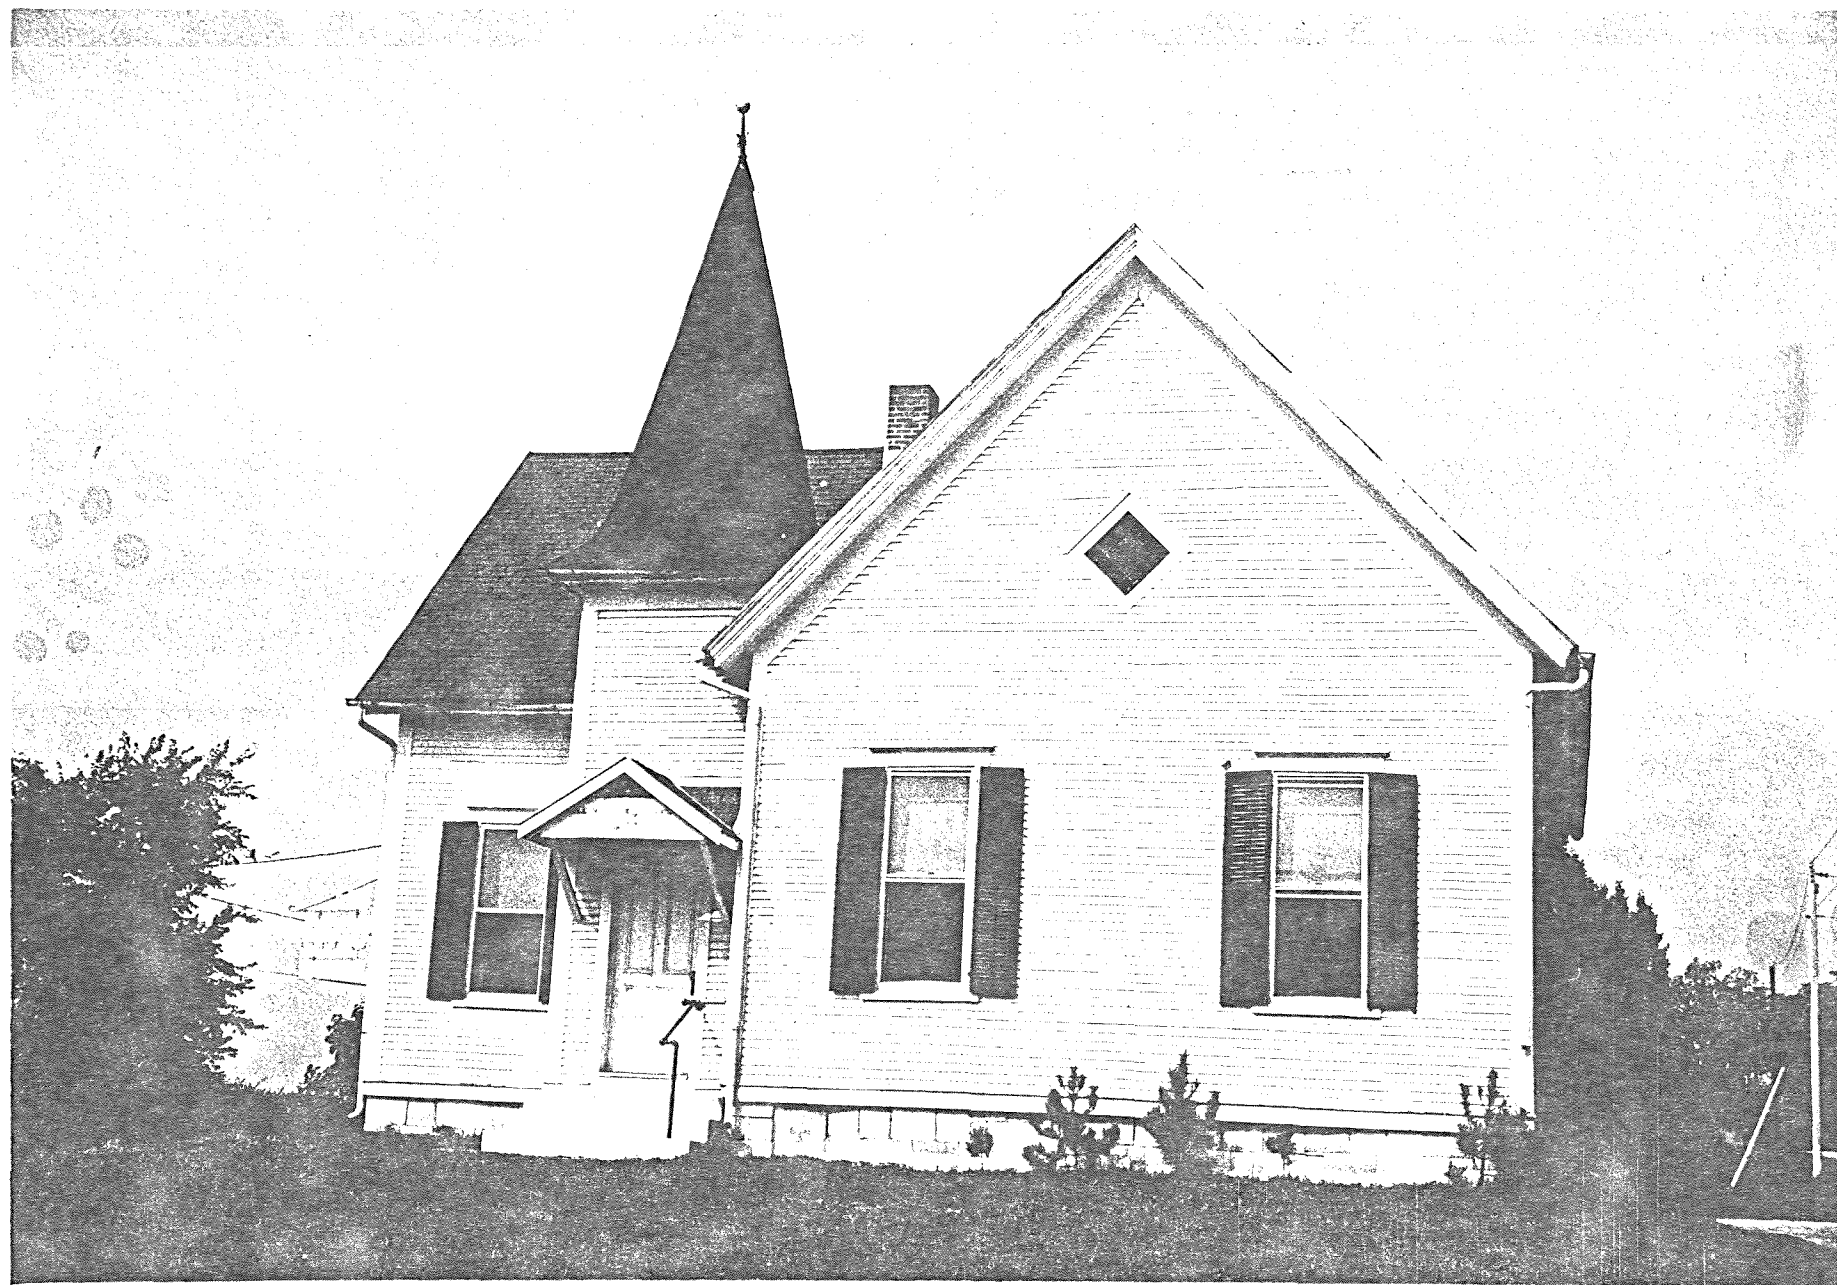
1120-2

The Mill Village Chapel has a two-bay facade and one-bay west wing. Between these two sections is an entrance tower. In addition to the door hood, the only trim on the building is a triangular gable window in both the wing and facade.

This very simple nondenominational chapel is the key building at an important intersection just north of Rutland City.

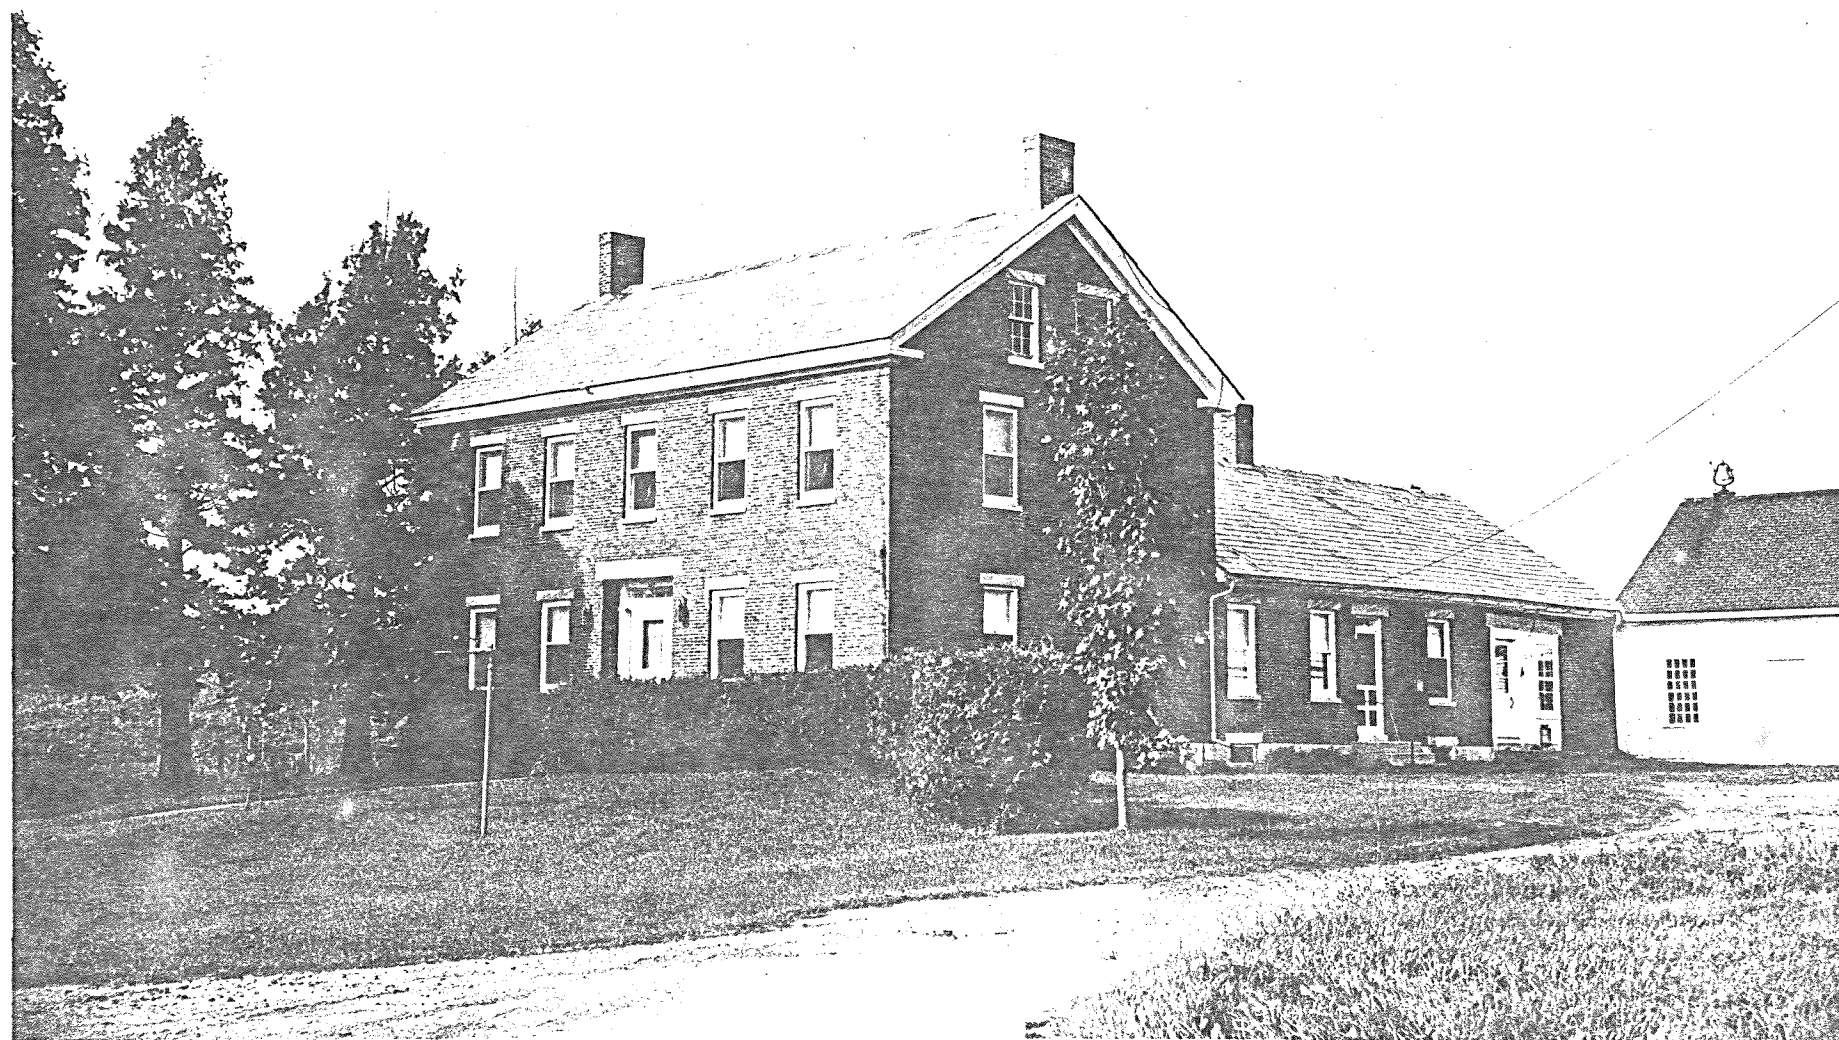
1120-3

The Baird House has a five-bay facade with a center entrance. To the rear is a one-story, brick ell. At the front entrance are sidelights and a transom with rectilinear muntins. The building has a deep cornice with returns and the windows are trimmed with marble sills and lintels.

The original exterior of this large brick farmhouse has survived virtually intact. Erected by William Barnes in 1836, it was later owned by the Chaplin family. In 1874 the farm was acquired by the Davis-Kelley families, from whom the current owner is descended.

The surrounding property, consisting of approximately 120 acres, is currently leased for farming. Located on Route 7, just north of Rutland City, the building and surrounding farmland are threatened by commercial zoning and nearby highway strip development.

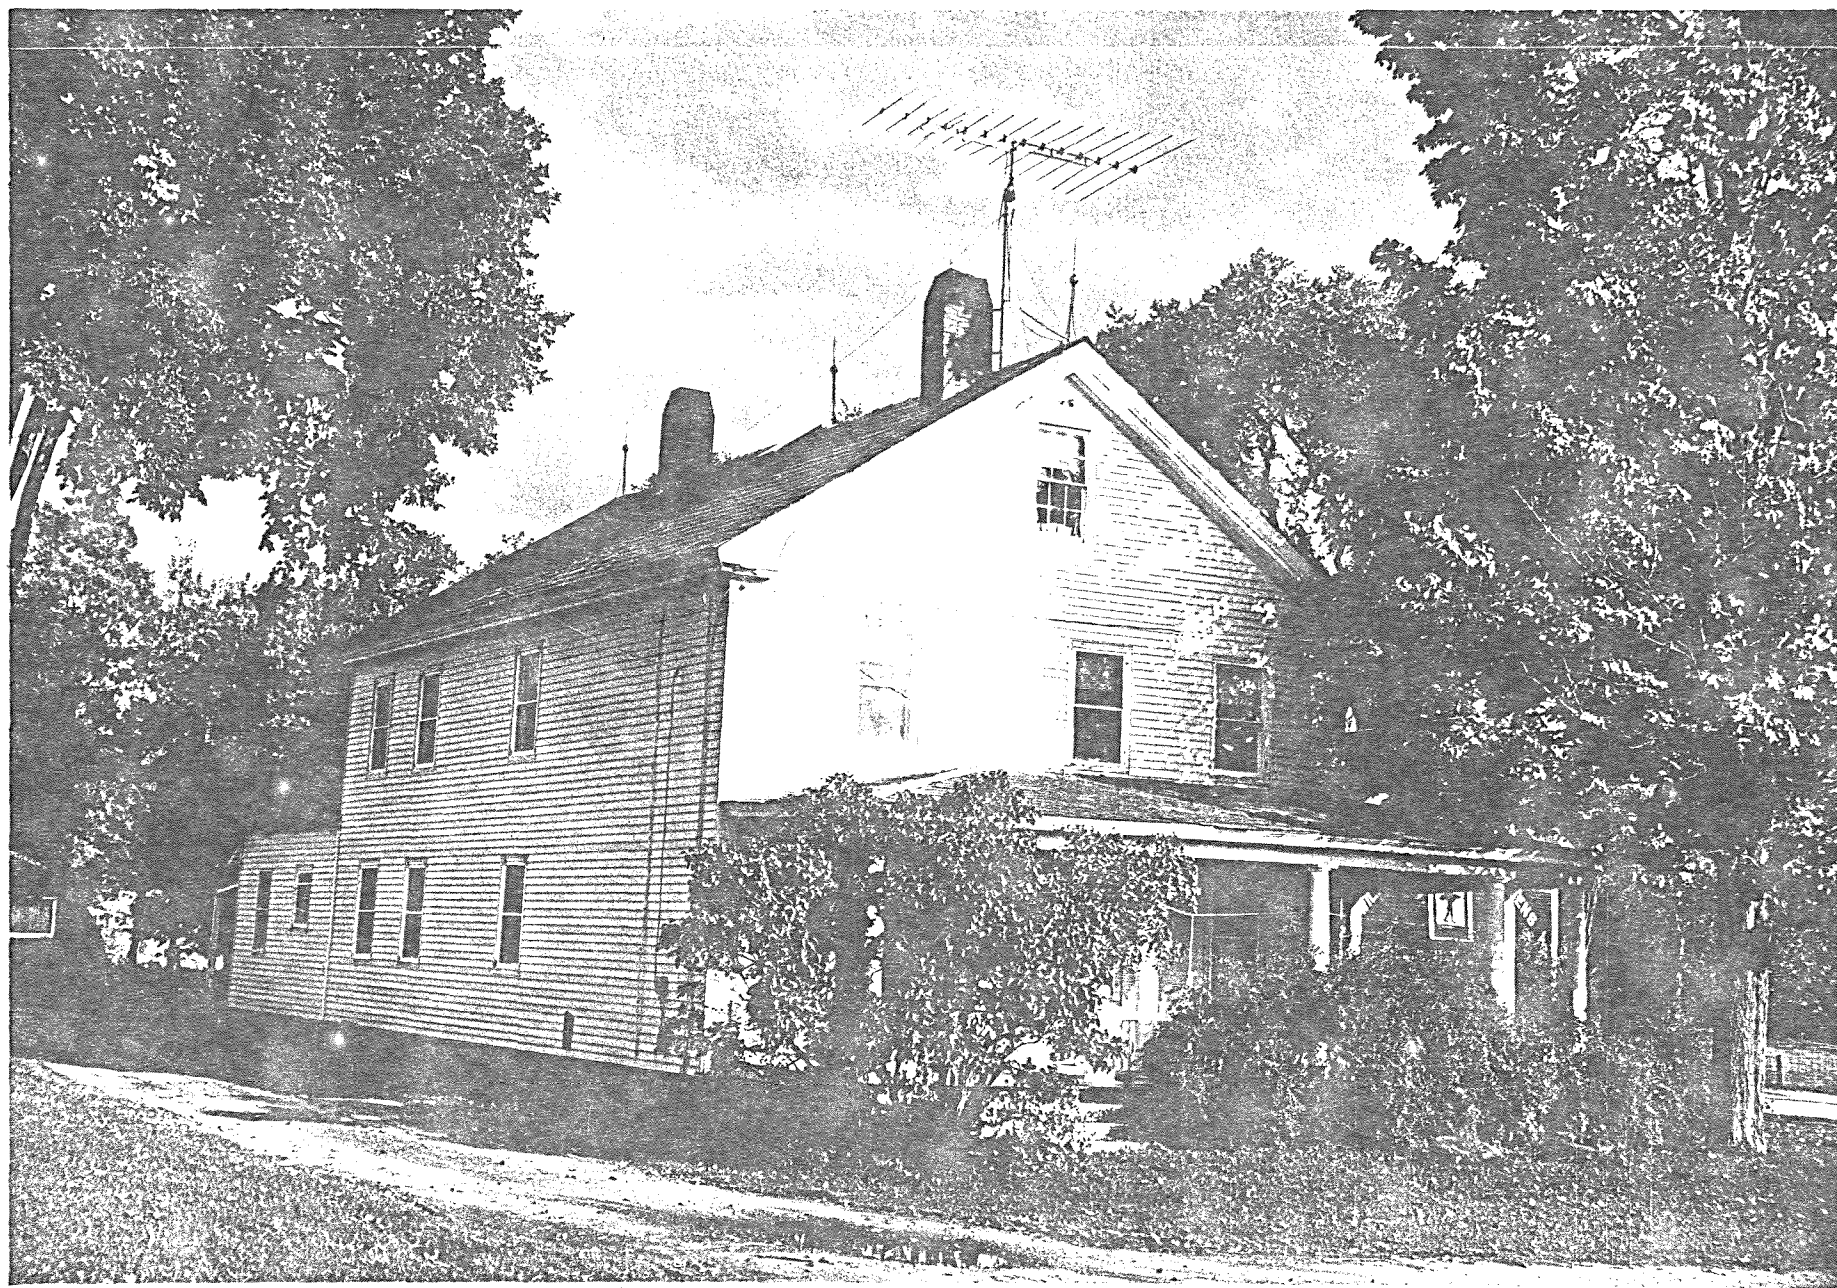
Map No. 1

OUTSTANDING COMPONENTS OF DISTRICT <input type="checkbox"/>		COMPLEX <input checked="" type="checkbox"/>
(Include individual survey number ONLY if surveyed individually.)		
MAP NUMBER: 1	DATE BUILT: c.1850s	SURVEY NUMBER: 1120-4
FUNCTIONAL TYPE: Residential		NEGATIVE FILE NUMBER: 75-A-67
COMMON NAME: Williams House		OWNER: Sherwin Williams
DESCRIPTION: Two-and-a-half-story, wood frame house with gable roof. Three-bay, side hall plan with Greek Revival-style detailing at entrance. Twentieth-century veranda.		
MAP NUMBER: 2	DATE BUILT: pre-1850	SURVEY NUMBER: 1120-4
FUNCTIONAL TYPE: Agricultural		NEGATIVE FILE NUMBER: 75-A-67
COMMON NAME: Produce shop		OWNER: Sherwin Williams
DESCRIPTION: One-story, gable-roofed barn with cupola. The facade is a late 19th century addition. The rear section has brick nogging and was used at one time for grain storage; said to date from the early 1800's.		
MAP NUMBER: 3	DATE BUILT: 1882	SURVEY NUMBER: 1120-4

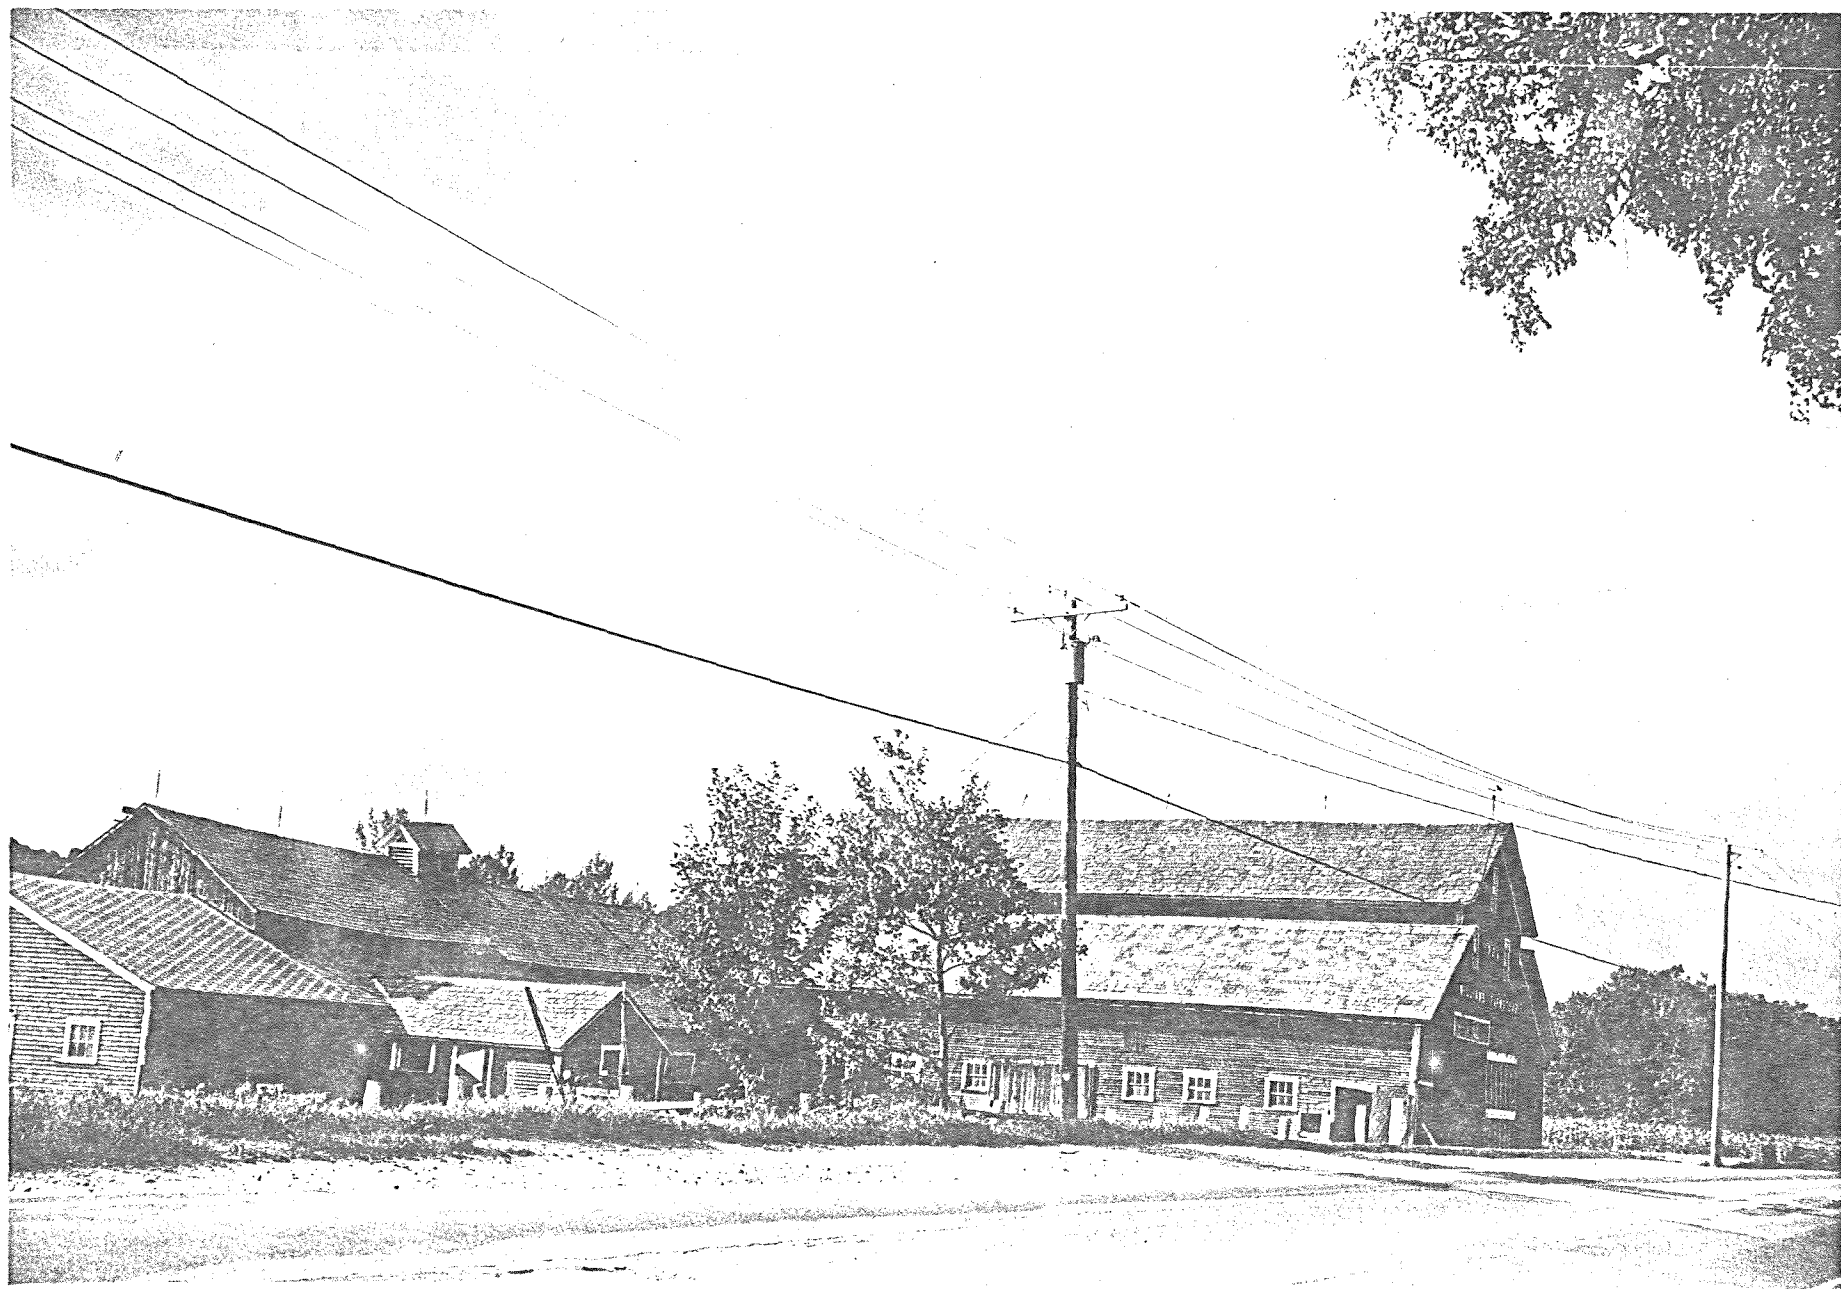
Map No.'s 4, 3

FUNCTIONAL TYPE: Agricultural		NEGATIVE FILE NUMBER: 75-A-67
COMMON NAME: Hay Barn		OWNER: Sherwin Williams
DESCRIPTION: Two-level, gable-roofed barn with raised center section and flanking sheds. Clapboard siding and multi-paned transom over front entrance. Basilica barn type.		
MAP NUMBER: 4	DATE BUILT: mid-1800	SURVEY NUMBER: 1120-4
FUNCTIONAL TYPE: Agricultural		NEGATIVE FILE NUMBER: 75-A-67
COMMON NAME: Dairy Barn		OWNER: Sherwin Williams
DESCRIPTION: One-story, gable-roofed barn with cupola. Predates attached large barn, (Map No. 3). Now used for dairy cows.		
MAP NUMBER: 5	DATE BUILT: pre-1850	SURVEY NUMBER: 1120-4
FUNCTIONAL TYPE: Agricultural		NEGATIVE FILE NUMBER:
COMMON NAME: Tool shed		OWNER: Sherwin Williams
DESCRIPTION: Small, one-story shed with gable-roof and vertical plank siding. Said to have been used as an ox barn.		
MAP NUMBER:	DATE BUILT:	SURVEY NUMBER:
FUNCTIONAL TYPE:		NEGATIVE FILE NUMBER:

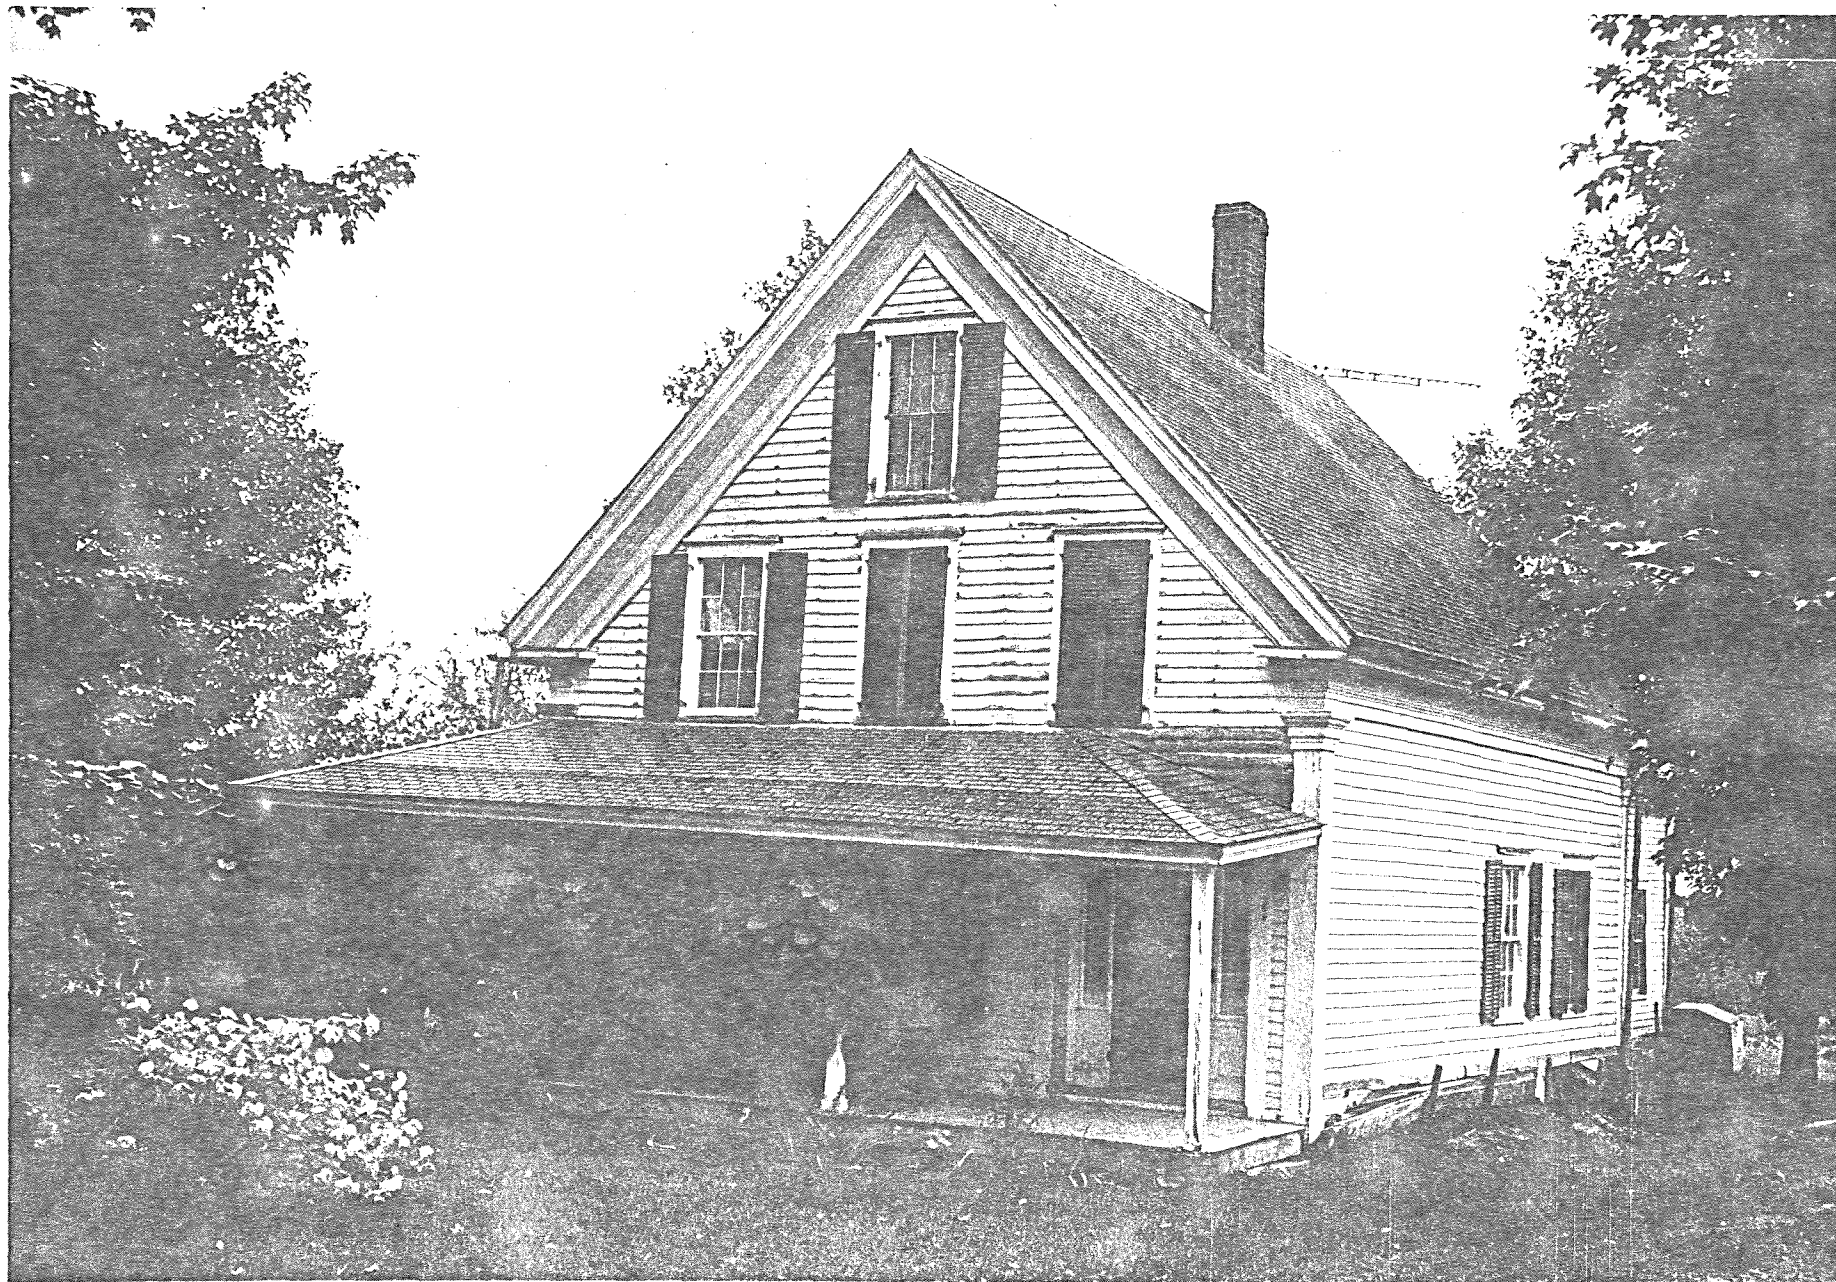
1120-5

Although the main block of this three-bay, gable-fronted house is of a size traditionally used for one-and-a-half-story buildings, its low interior walls allow for a full two-and-a-half-stories. The building's detailing includes corner pilasters, full entablature at the eaves and gable, sidelights at the entrance, and a veranda with corner posts. At the rear is an ell built in several stages.

This Greek Revival-style farmhouse is located on a narrow road lined with large maple trees. In the mid-19th century it was owned by the Dunklee family and has survived virtually intact. The building is a typical example of the few small, Greek Revival-style remaining in Rutland Town.

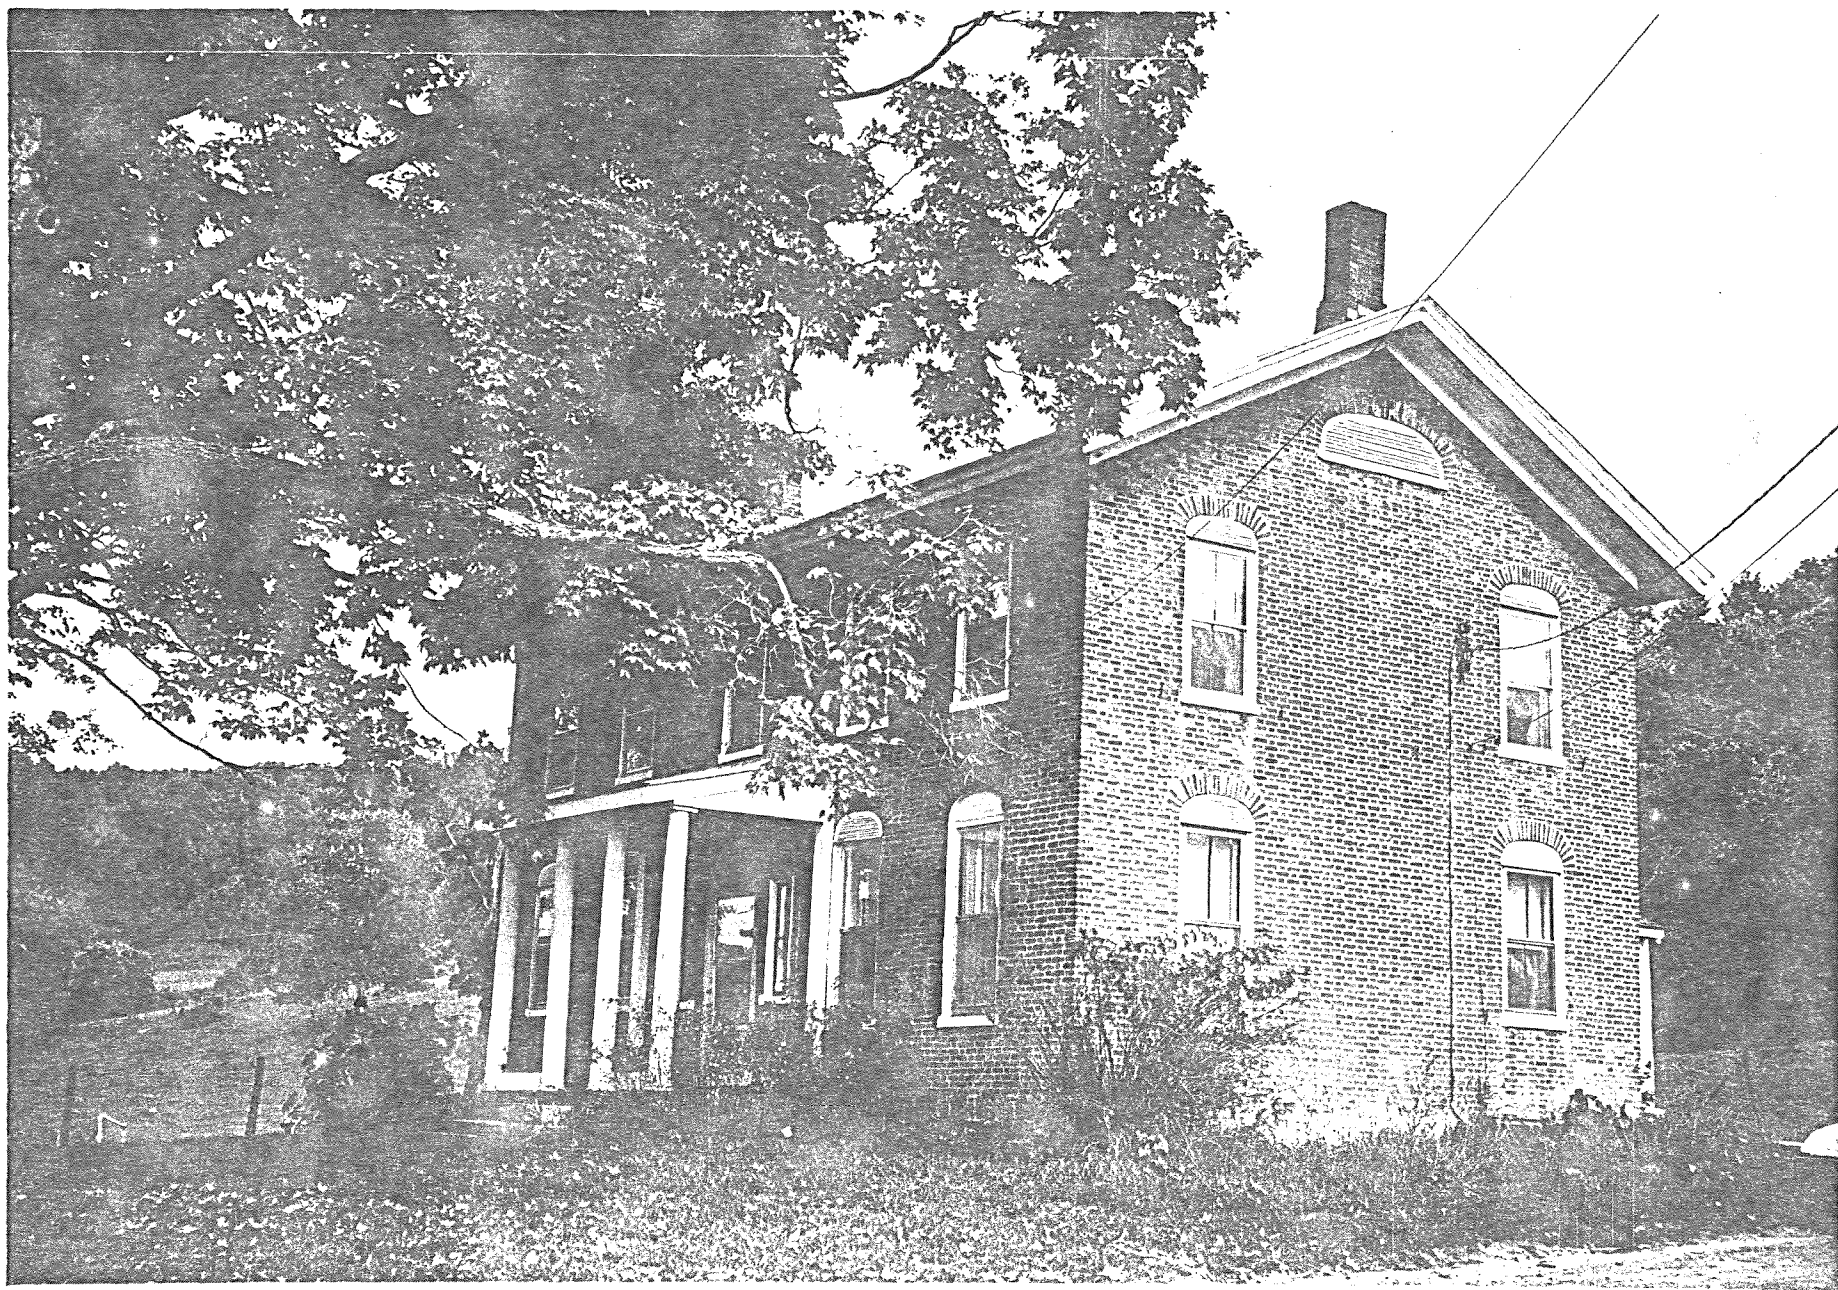
1120-6

This substantial Federal-style house was owned by the Griggs family during the 19th century. Its fine exterior detailing has survived intact.

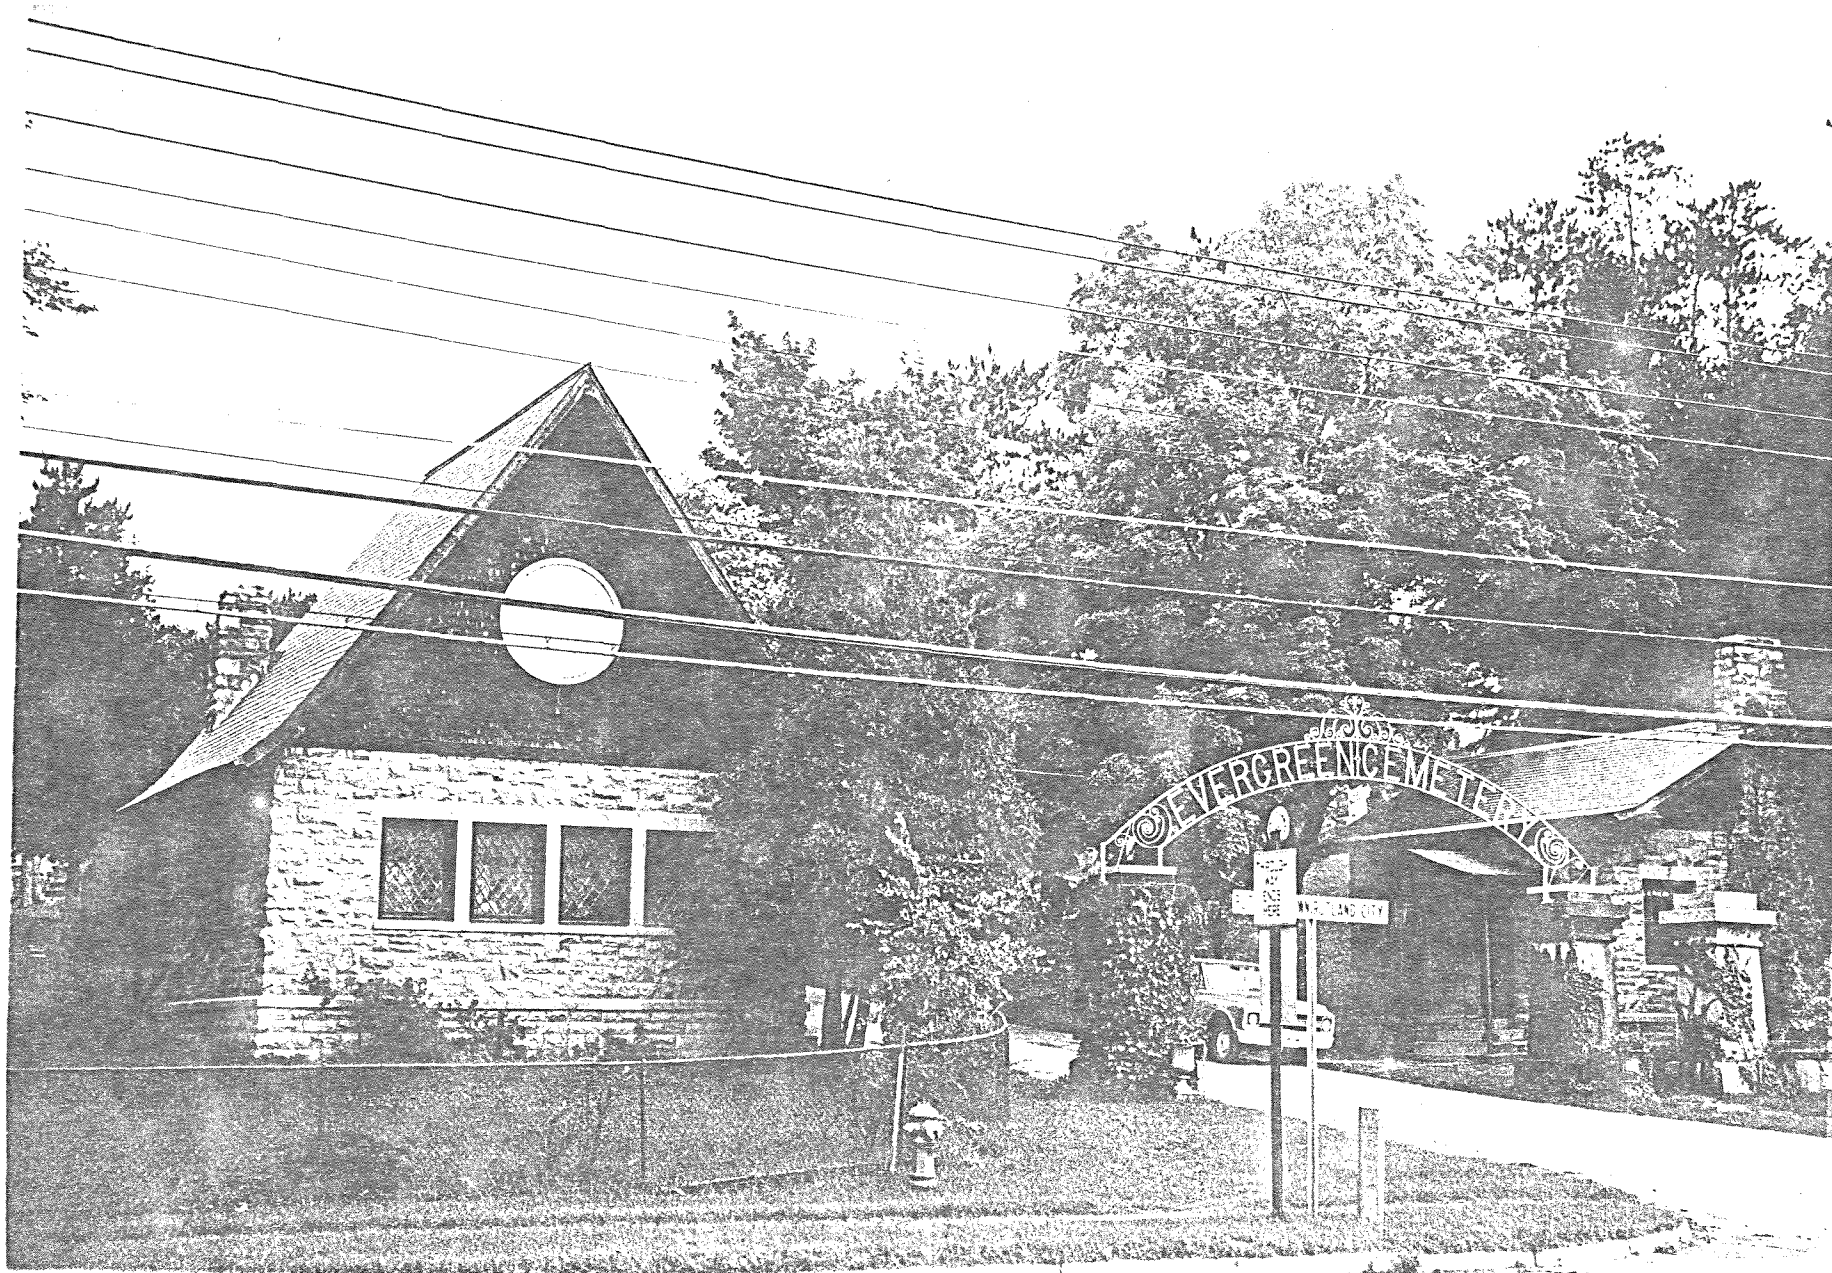
Map No.'s 1, 2, 3

MAP NUMBER: 2	DATE BUILT: c.1900	SURVEY NUMBER: 1120-9
FUNCTIONAL TYPE: Office		NEGATIVE FILE NUMBER: 75-A-68
COMMON NAME: Evergreen Cemetery		OWNER: Evergreen Cemetery Assn.
DESCRIPTION: Office Small, one-story building with gable roof and exterior south chimney. Rusticated marble ashlar walls and shingled gable ends. Overhanging eaves.

MAP NUMBER: 3	DATE BUILT: c.1900	SURVEY NUMBER: 1120-9
FUNCTIONAL TYPE: Chapel		NEGATIVE FILE NUMBER: 75-A-68
COMMON NAME: Evergreen Cemetery		OWNER: Evergreen Cemetery Assn.
DESCRIPTION: Chapel Small, one-story building with steeply pitched gable roof and curved overhang. Diamond-paned ribbon windows in north and south walls and center entrance on east facade. Rusticated marble (cont.)

ashlar construction with shingled gable ends. Vacant.

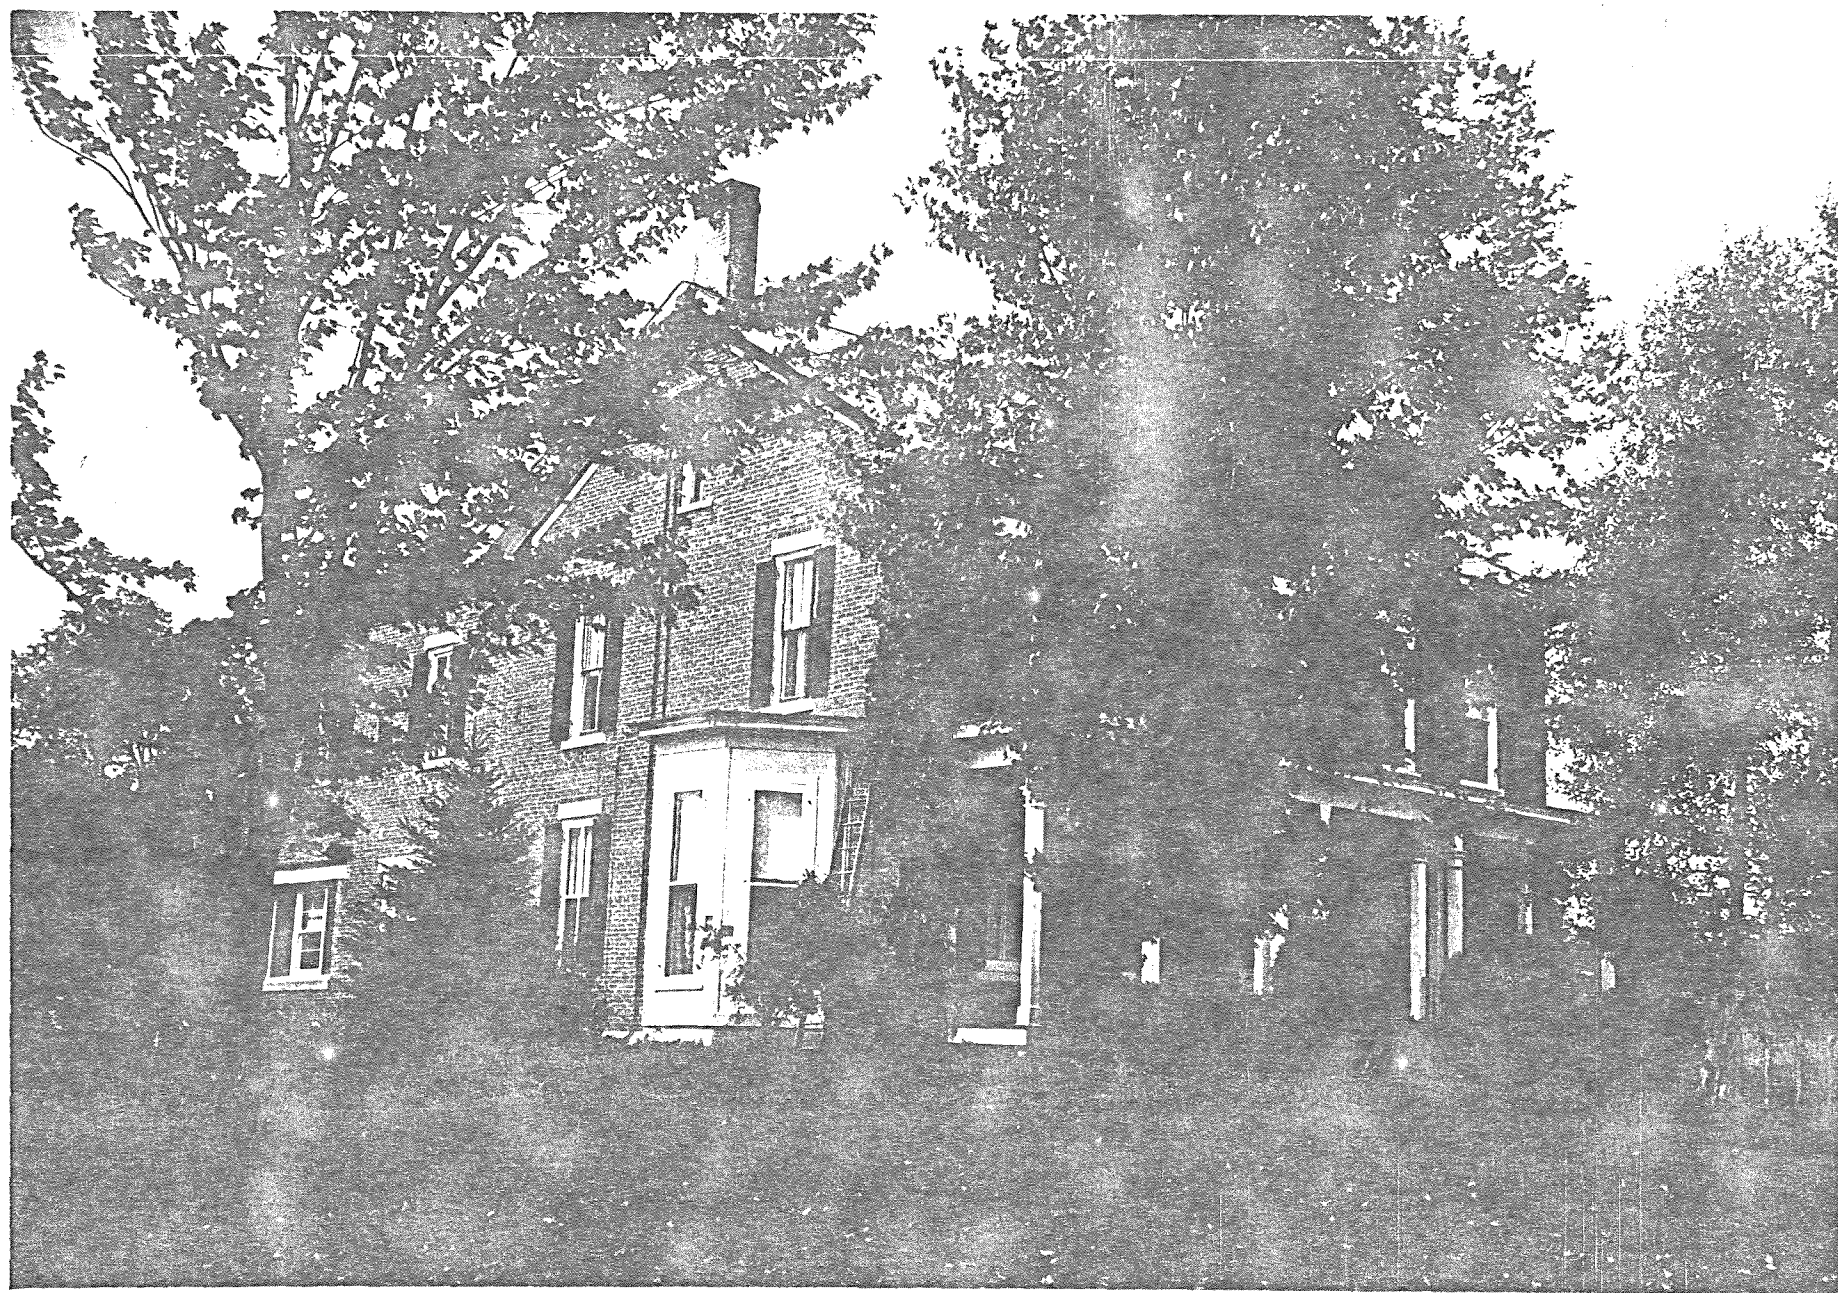
1120-10

This large brick farmhouse is said to have been erected by Isaiah Root. Shortly afterward it was bought by Jesse L. Billings and is still owned by the Billings family. The building, designed with an unusual, narrow center pavilion, is in substantially original condition.
