VERMONT DIVISION FOR HISTORIC PRESERVATION
HISTORIC SITES & STRUCTURES SURVEY

RUTLAND COUNTY

RUTLAND TOWN

HISTORIC SITES & STRUCTURES SURVEY
Individual Structure Survey Form

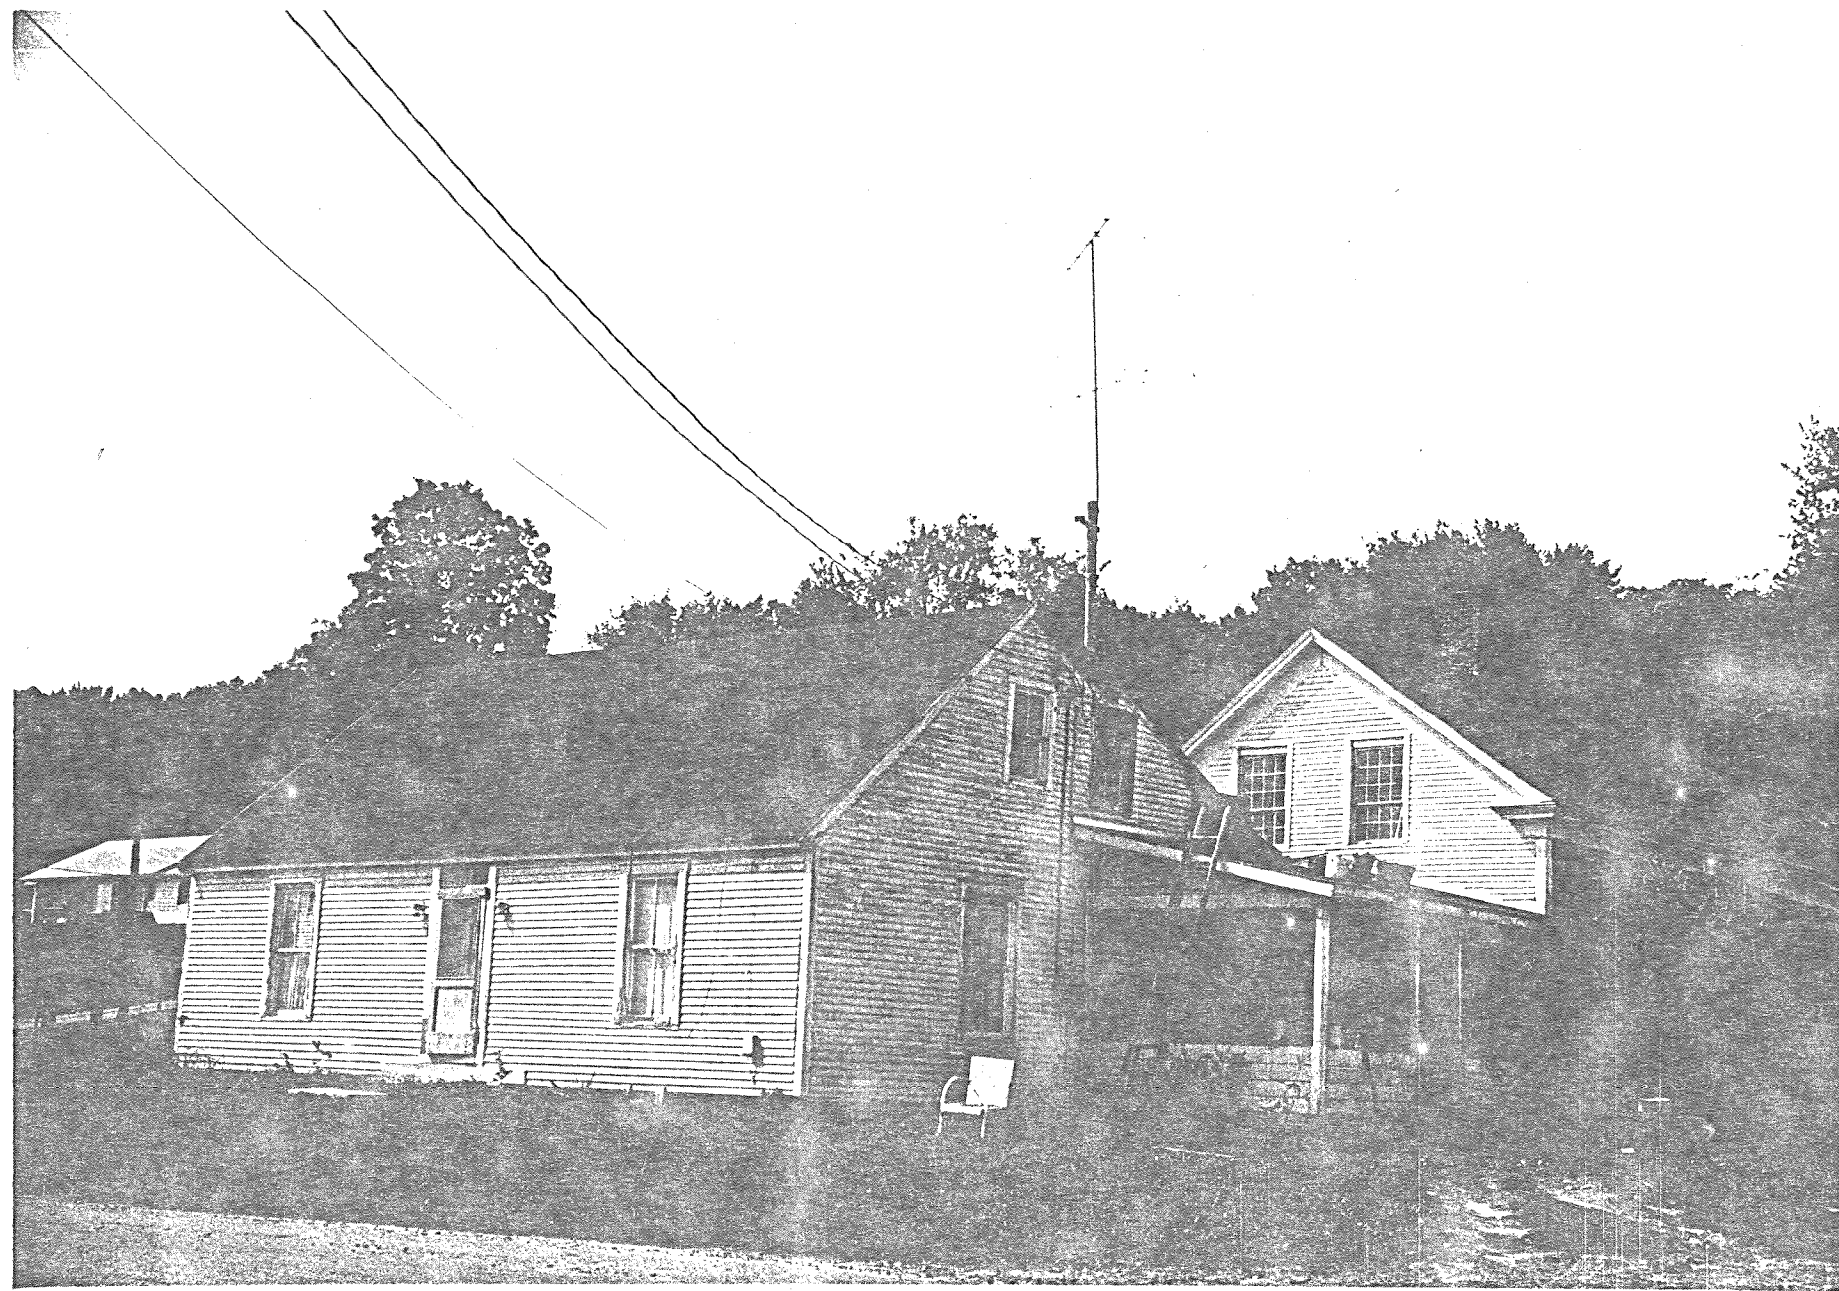
Survey Number: 1120-11

brick foundation, rarely found in early Rutland County buildings, suggests that the house may have been moved to its present location.

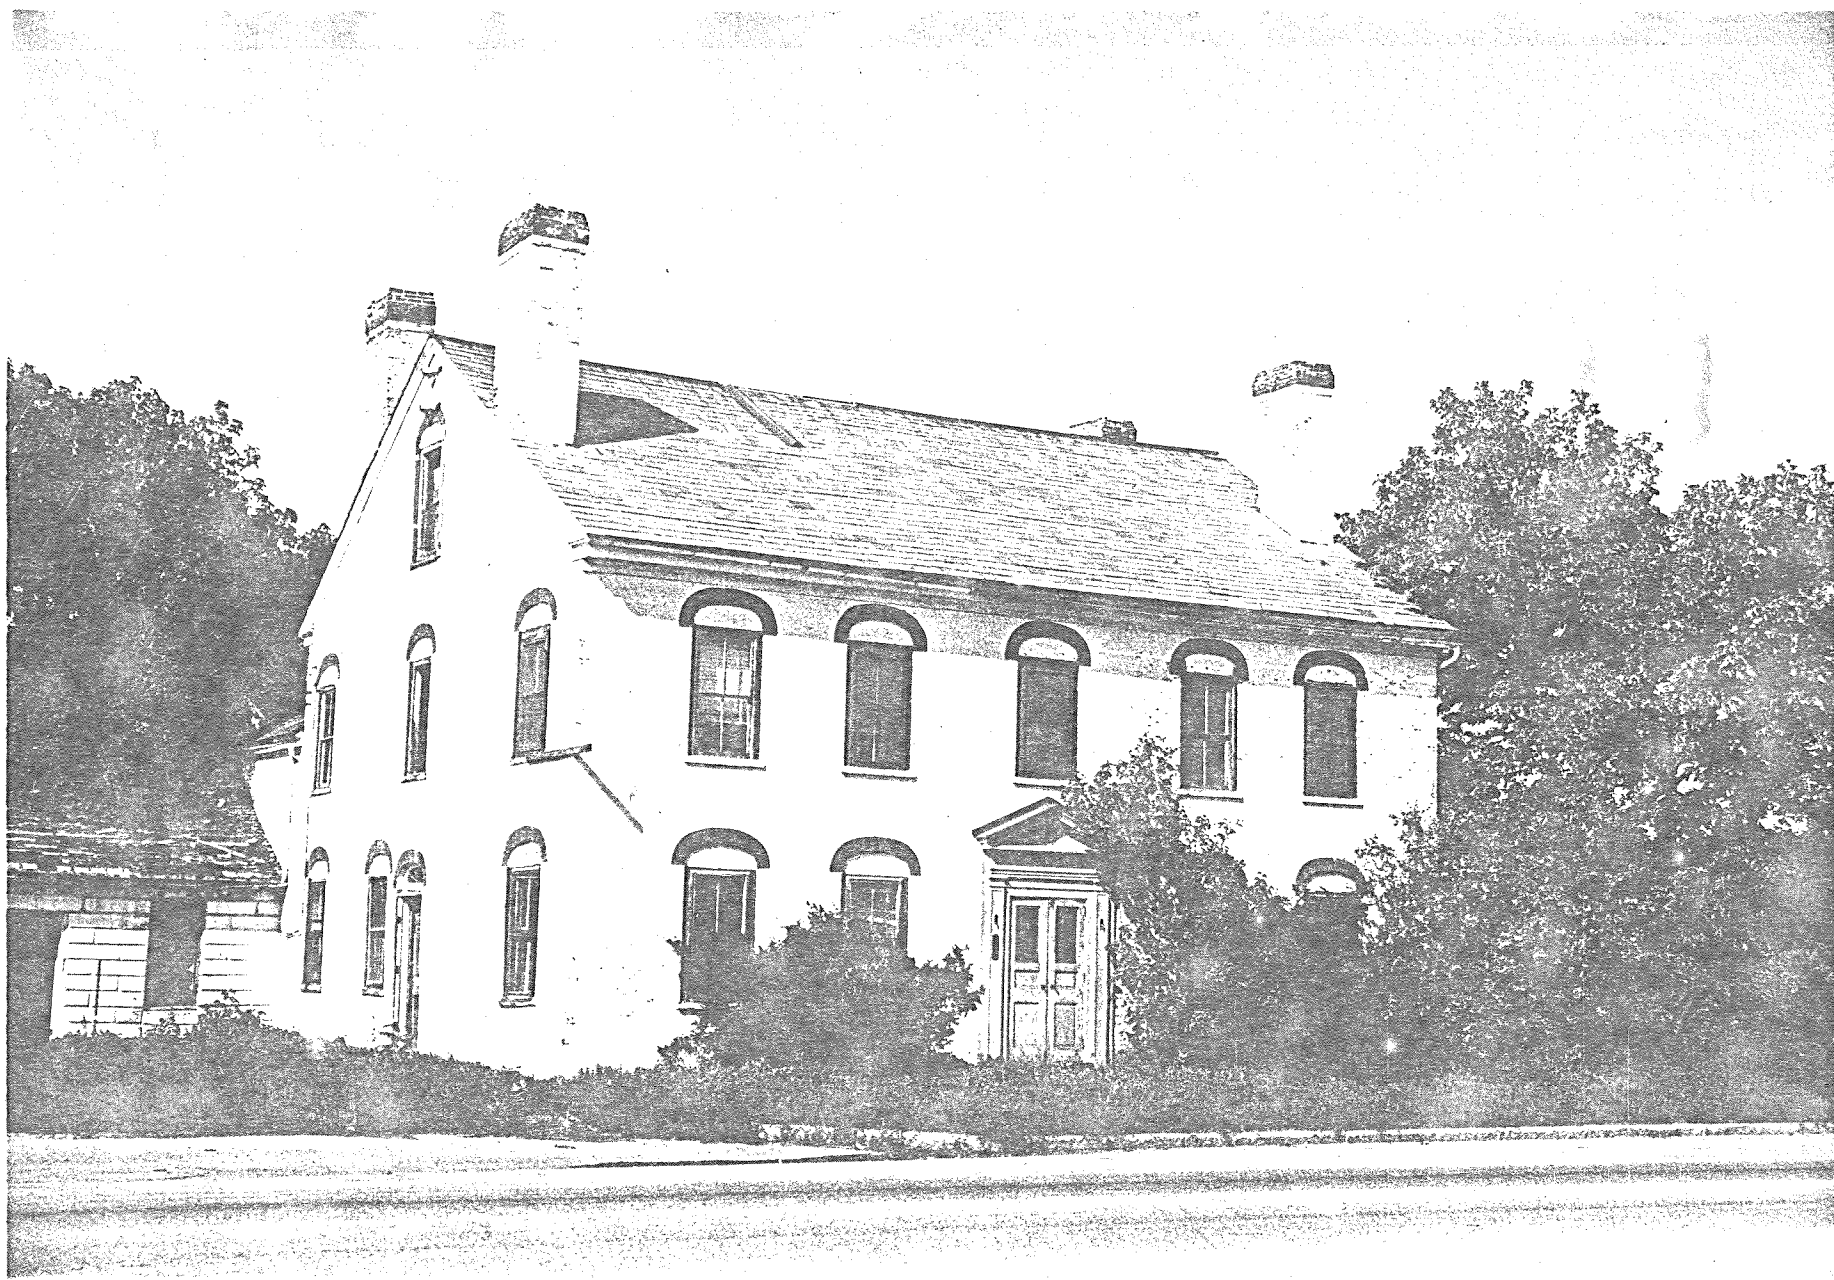
1120-12

Deteriorated ☒

The house was owned during the 19th century by the Green family.
